Manhole Inspection Summary

Manhole # S21EE2012MH

Insp Date: **3/6/07 9:14 PM**

Location Address: **5719 FALLS RD**

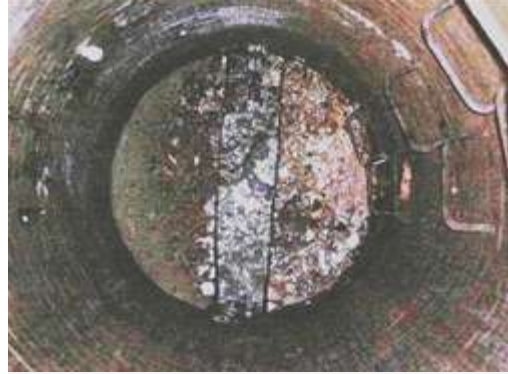
Top View

Bench debris. Channel debris. Corroded steps.

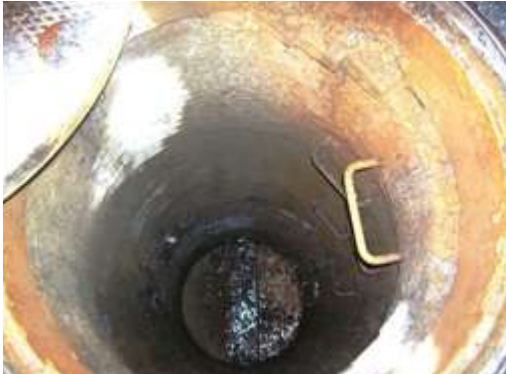
Defect

Frame leaks. Frame offset. Adjustment deterioration, loose brick and infiltration. Corbel and Barrel infiltration - other side.

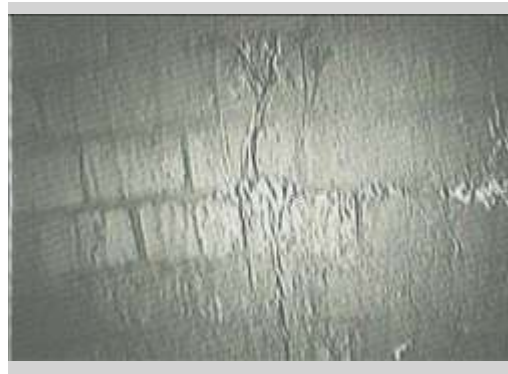
Defect

Barrel root intrusion and infiltration.

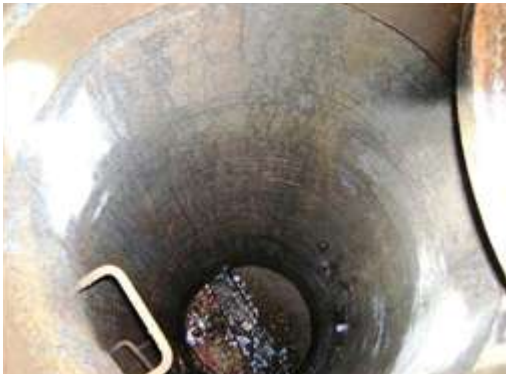
Defect

Adjustment, Corbel and Barrel infiltration.

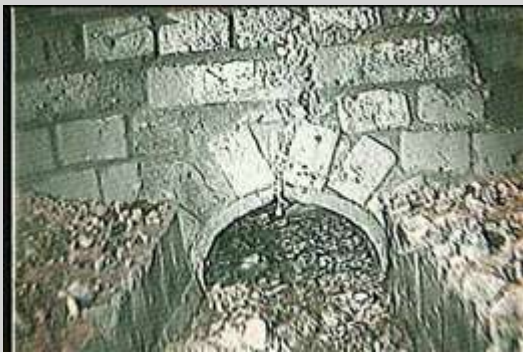
10 in. Circular Gravity Sewer Pipe Out @ 12 O'Clock

Deposits: ☐ None ☒ **Mud** ☐ Sludge ☒ **Debris** ☒ **Grease**

Silt Depth: **4** (in.) Deposits Extent: **Heavy**

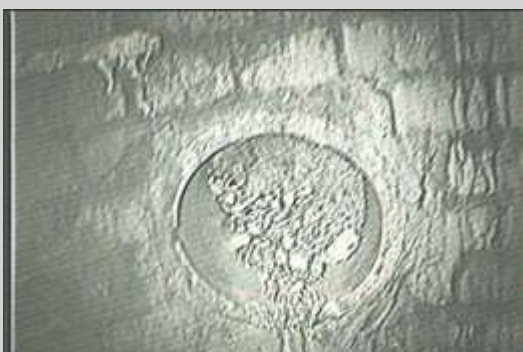
8 in. Circular Gravity Sewer Pipe In @ 3 O'Clock

Deposits: ☐ None ☒ **Mud** ☐ Sludge ☒ **Debris** ☐ Grease

Silt Depth: **4** (in.) Deposits Extent: **Medium**

Infiltration: **Evidence** Pipe Seal Cond: **Unknown**

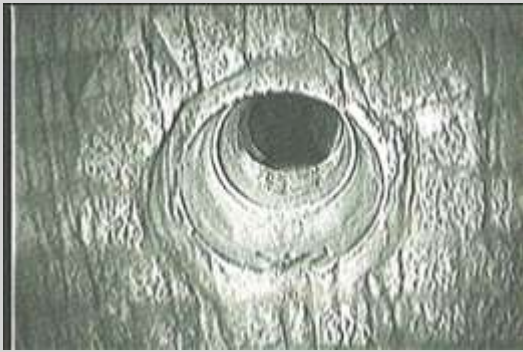
Pipe In @ 6 O'Clock

Comments **The I6 pipe in picture shows Barrel cracks and infiltration.**

Barrel cracks and infiltration.

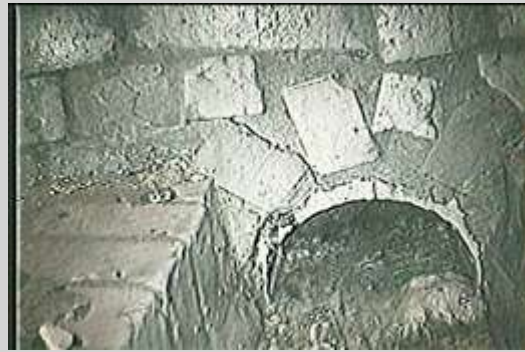
Drop In @ 6 O'Clock

Deposits: ☐ None ☒ **Mud** ☐ Sludge ☒ **Debris** ☐ Grease

Infiltration: **Evidence**

Pipe Seal Cond: **Roots**
